Audio Restoration Project: Fisher 500-C Tube Receiver with 7591A IBBA PCB – also applies to 500-B, 800-B and 800-C

This Project is suitable for all versions of the Fisher receivers which have the ECC83/12AX7 Driver and 7591 Output Tubes – as far as I have inspected the schematics – 500B 500C 800B 800C. There may be others.

The objective of this project is to present the absolute minimum restoration work required to ensure a properly functioning Fisher 500 or 800, which is reliable for decades to come. There are additional interesting enhancements which you can do (visit AudioKarma), but these are not in the scope of this primarily safety-oriented overhaul.

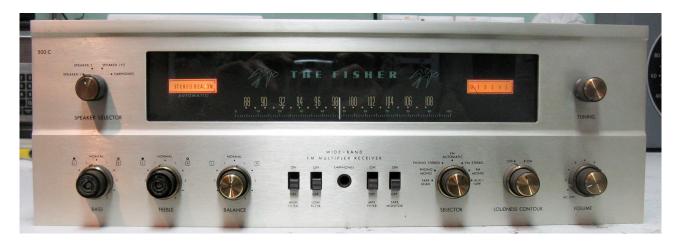
This project includes installing 2x IBBA PCB's (custom-designed by myself), which enables the EXACT Adjustment and Regulation of Bias Voltage and Current, ensuring the coolest and most-efficient operation of the new 4x EH 7591A Output Tubes. One PCB is for the Left Channel, and One PCB is for the Right Channel.

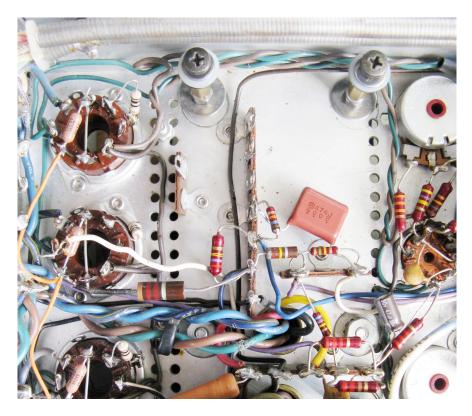
The **<u>First group</u>** of components to remove, are the links between the ECC83/12AX7 Driver section, and the Output Tubes. These will be upgraded by the 2 IBBA PCB's.

C77 C78 C79 C80 - 0.047uF - On PCB: Wima MKS2 or similar 0.10uF/630V (pitch 15mm). R121 R122 R123 R124 - 330K- On PCB: Vishay RN60 220K. R126 R127 R129 R130 - 1K - On PCB: Vishay RN60 1K. C82 C84 - 10pF or 18pF - On PCB: Ceramic NP0 18pF (pitch 5mm).

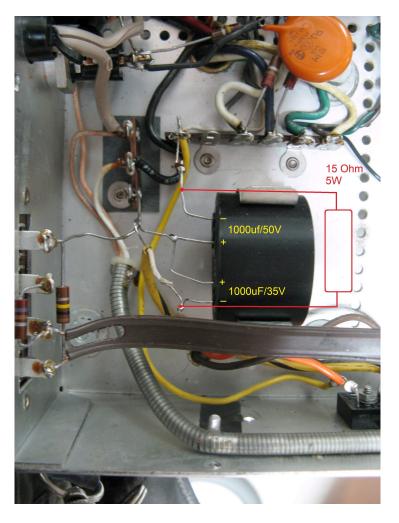
4. Install Bridge Rectifier CR6.

This enables the Bias Voltage to be increased to 30VDC.

In place of the Selenium Rectifier, bolt the new KBPC810 Full-Wave Rectifier to the chassis at the same location. As before, the Orange and Brown wires are the 25VAC inputs to the Bridge.

Solder the +ve Terminal directly to Chassis Ground.

Solder the –ve Terminal directly to the White Bias Voltage Wire at the Terminal block End lug in the area of the Fuse. This is where R131 and R132 were previously connected.

Now Solder two items to the White wire at the End lug:

- 1. the -ve lead of the New 1000uF/50V capacitor
- 2. one lead of the 15 Ohm 5W resistor which you removed with the Selenium Rectifier.

Now Solder two items to the -ve lead of the New 100uf/35V capacitor:

- 1. the other lead of the 15 Ohm 5W resistor
- 2. the White internal power lead of the Yellow/Black Tube Heater cable

Now Solder three items to the Ground lug, directly adjacent to the above End lug:

- 1. The +ve lead of the 1000uF/35V capacitor
- 2. The +ve lead of the 1000uF/50V capacitor
- 3. The Bare internal screen lead of the Yellow/Black Tube Heater cable

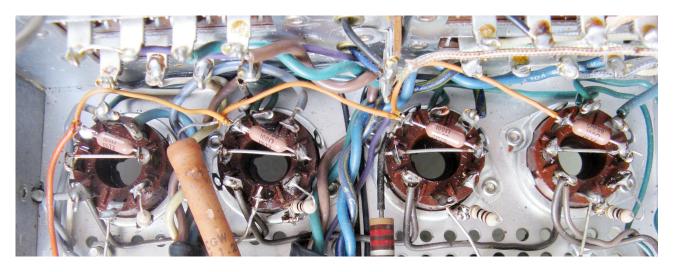
5. Modifying the Output Tube Sockets.

On the sockets for V8 V9 V10 V11:

- 1. Install 4x 10 Ohm Bias Current resistors, between Pin 5 and Ground Pin 5 is currently shorted to Ground.
- 2. Install 4x 100 Ohm Screen protection resistors, between Pin 1 and Pin 4.
- 3. Continue the Orange cable to each of the 4 sockets at Pin 1.
- 4. Short Pin 4 to Pin 8 on each socket.

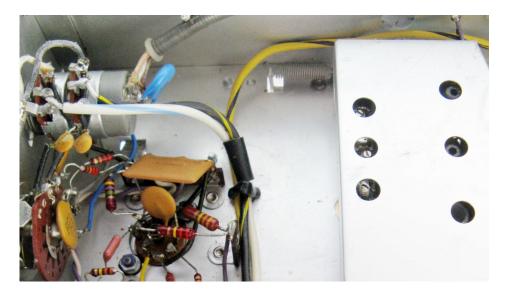
1. Install 0.01uF/400V Snubber capacitor between the On/Off of Volume Control switch.

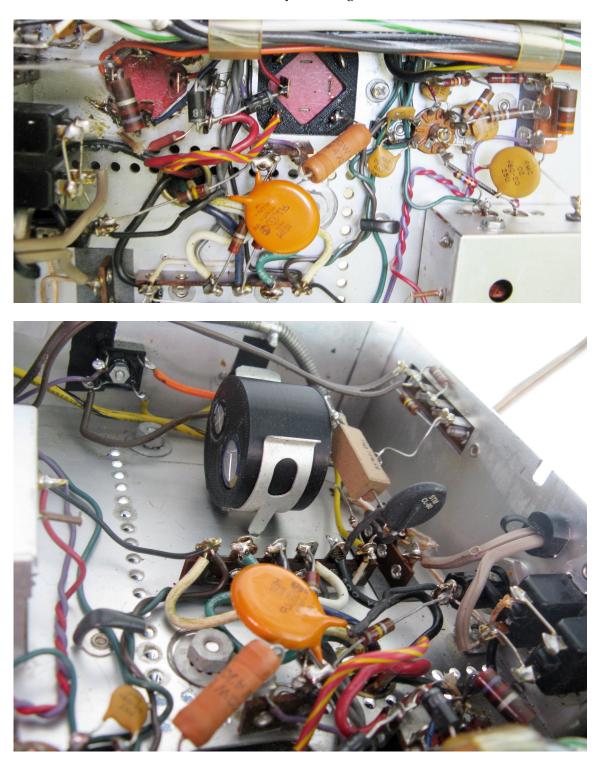
3. CL80 Thermistor – enables gradual warmup of the tubes, without power spikes. Install in series with the Mains Transformer Primary Winding, AFTER the On/Off switch.

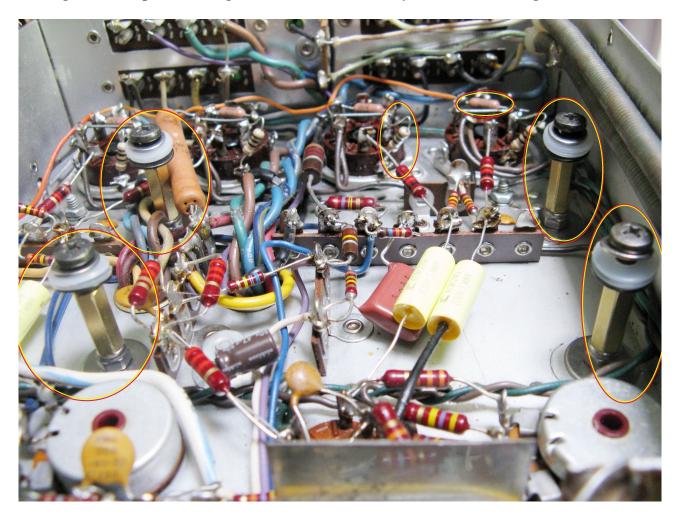
7. Assemble and Install 2 Custom IBBA PCB's - Mounting Hardware.

On each of the Speaker transformers, remove 2 of the original mounting bolts, and replace them with the following M4 components, according to the photos.

In this photo, disregard the components which have <u>already been removed</u>, as per Para 2 above.

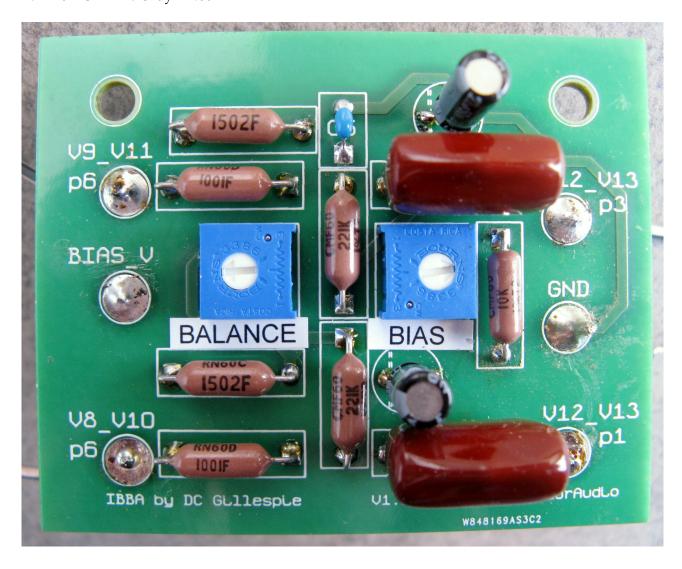
8. Assemble and Install 2 Custom IBBA PCB's - Electronic Components.

C1 C4 - 0.10uF/630V Film - Wima MKS2 (Pitch=15mm), or similar C2 C3 - 22uF/50V - Nichicon HE or PW C5 - 18pF/630V - Ceramic NP0 - Murata (Pitch=5mm) R1 R7 - 1K Ohm - Vishay RN60 R2 R6 - 220K Ohm - Vishay RN60 R3 R8 - 10K Ohm Potentiometer Bourns Cermet 3386F, 3386P or 3386Y R4 R5 - 15K Ohm - Vishay RN60 R9 - 10K Ohm - Vishay RN60

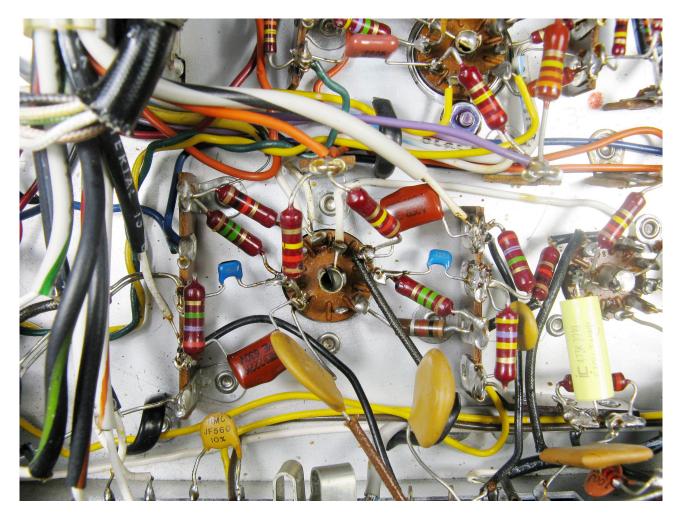
9. Repair the L-R channel imbalance.

With my Signal Generator, I fed a 1KHz 500mVpp Sine-wave into the L&R Aux RCA inputs, and scope-traced the signal path, looking for a discrepancy between the amplitudes of the Left and Right channels.

At V14 (V15 on the schematic!!), I detected the imbalance.

I replaced C35 C36 (0.001uF) at Pins 2 and 7, and C38 C40 (0.0022uF) at Pins 1 and 6. That solved the problem.

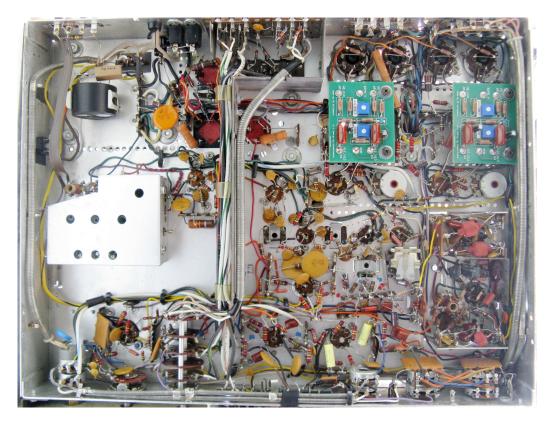
11. Expected Results - Electrical Measurements.

Similar measurements for both Left and Right Channels – Reference Chassis Ground.

Bias Voltage: -29.9VDC V8 V9 Pin 5: 323mVDC (32.3mA) V8 V9 Pin 6: -17.7VDC V12 Pin 1: 322VDC V12 Pin 3: 148VDC Tube Heater: -25.2VDC Mains AC Current Consumption: 1.48A

Bias Voltage: -29.4VDC V8 V9 Pin 5: 317mVDC (31.7mA) V8 V9 Pin 6: -19.4VDC V12 Pin 1: 315VDC V12 Pin 3: 142VDC Tube Heater: -24.4VDC Mains AC Current Consumption: 1.51A

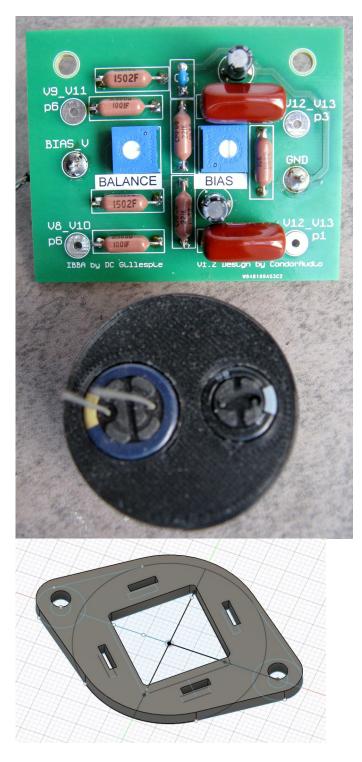
12. Custom Parts designed by myself, used in this project.

IBBA PCB

3D Capacitor Holder for 2x 1000uF 3D C98 Standoff
